# U.S. PUBLIC LAND SURVEY MONUMENT RECORD

T. 3N., R. 13E

HARMONY TWP  
ROCK COUNTY WI

CORNER CODE J7 (2)

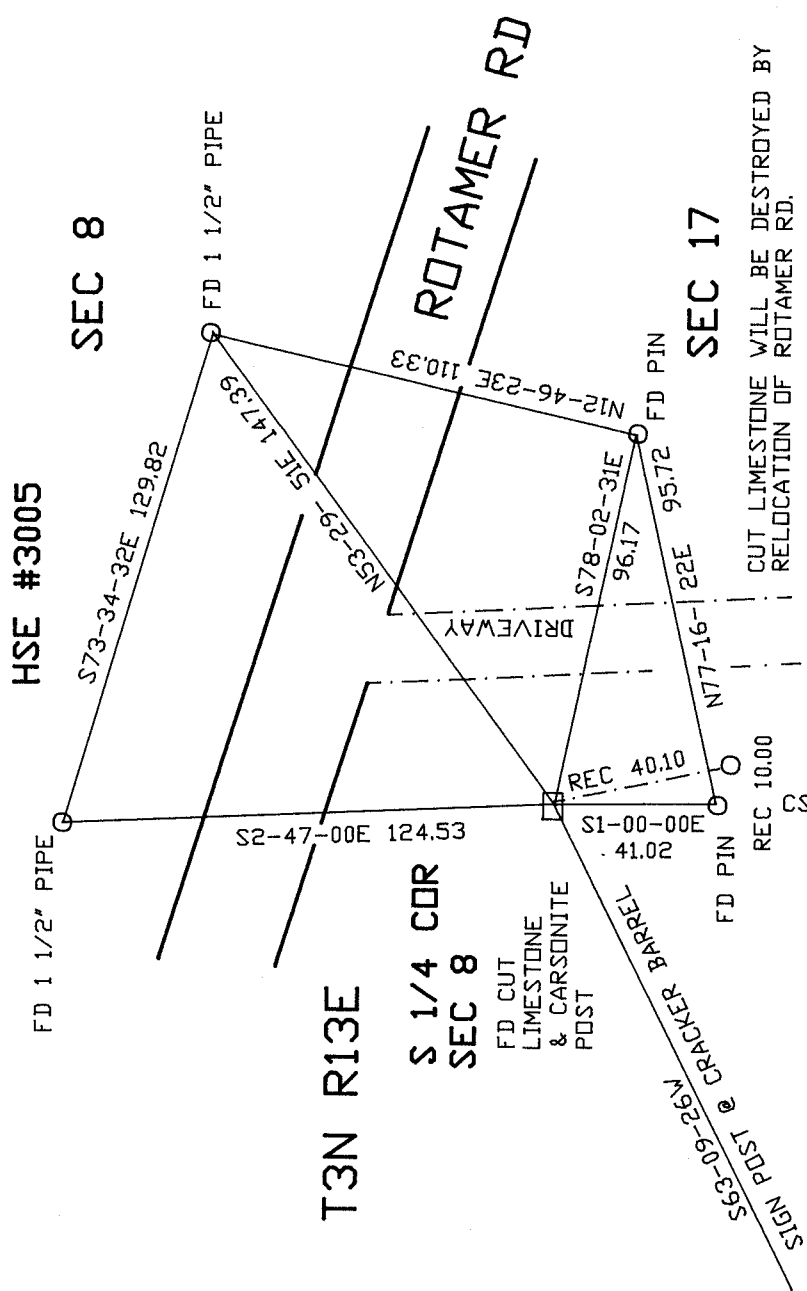
OBSERVATION SHEET

CUT LIMESTONE WILL BE DESTROYED BY RELOCATION OF ROTAMER RD.

S 1/4 CDR  
SEC 8

FD CUT  
LIMESTONE  
& CARSONITE  
POST

STGN POST @ CRACKER BARREL
