U.S. PUBLIC LAND SURVEY MONUMENT RECORD

T. 3 N. - R. 10 E. of the 4th P.M.

MAGNOLIA TWP
ROCK COUNTY WI

CORNER CODE: V-7
(A.E. 7.08 REQUIREMENT)

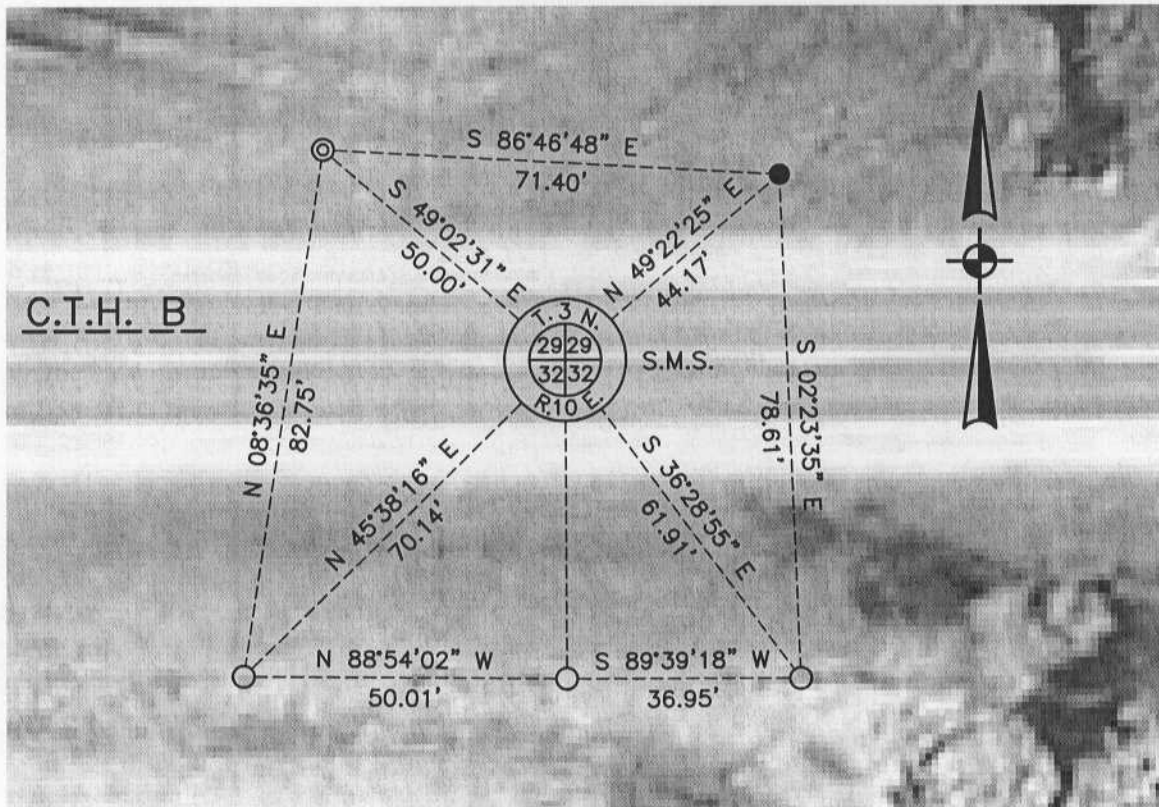
(a) LEGEND

I found four of the reference monuments shown on the V-7 monument record prepared by Barnes in 1985. There was not a surface monument however, I believe one exists below the pavement based on metal detection. By distance/distance intersection from the SW and SE monuments found, I calculated the location of the PLSS corner; checks to the other two references were acceptable. I set an aluminum "Survey marker" at the corner, (3" long with 1" head, +/-). One additional witness was set per the sketch and other monuments from surveys in the area were located, but are not shown on the map.

This PLSS corner was obliterated and restored from record witnesses.

I did not find a discrepancy between the corner restored and a previously documented corner location. *Discrepancy* being defined as *disagreeing* with a corner location, *not* as noting dimensional differences between current/former tie sheets due to measuring methods. The current and *most recent* tie-sheet dimensions filed for the corner are noted.
