U.S. PUBLIC LAND SURVEY MONUMENT RECORD

T. 3 N. - R. 10 E. of the 4th P.M.

MAGNOLIA TWP
ROCK COUNTY WI

CORNER CODE: Z-23
(A.E. 7.08 REQUIREMENT)

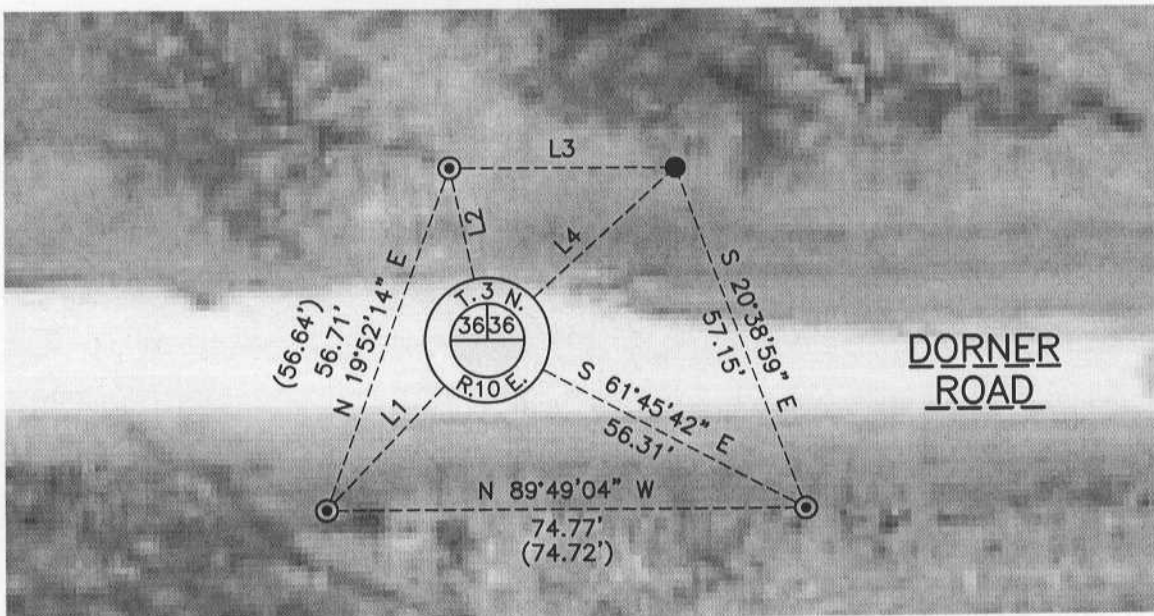
(a) LEGEND

LINE	BEARING	DISTANCE
L1	N 43°36'48" E	36.47'
L2	N 12°19'20" W	27.57'
L3	S 89°51'05" E	35.34'
L4	S 47°39'50" W	39.85'

I found 3 witnesses as detailed on the Z-23 tie-sheet filed in 1998, (Barnes). I did not find a monument at the corner and a 4th witness, (Northeast), is most likely there but, in an area inaccessible without trimming much brush/landscaping. I computed the PLSS corner location by distance/distance intersection from the 2 southerly witnesses; the 3rd witness, (NW), checks. I set a cotton gin spindle at the corner and one additional witness per the map. *NOTE: This is also the North 1/4 corner of Section 1, Town of Spring Valley.*

I also found a railroad spike north of the PLSS corner as shown on the Barnes tie-sheet. For reference the coordinates for the spike, (no dimple/approximate center), are: N-265204.74, E-429842.46
