U.S. PUBLIC LAND SURVEY MONUMENT RECORD

T. 3 N. - R. 10 E. of the 4th P.M.

MAGNOLIA TWP
ROCK COUNTY WI

CORNER CODE: X-9
(A.E. 7.08 REQUIREMENT)

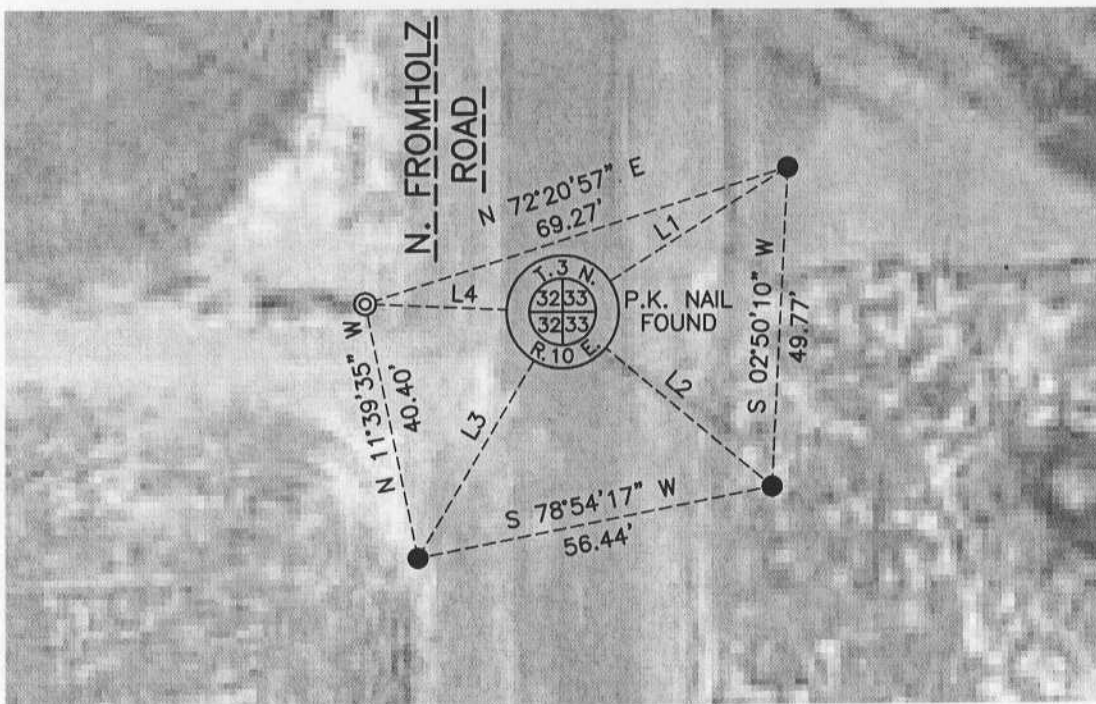
(a) LEGEND

- - 3/4" x 24" REBAR SET, (RED CAP W/"PLSS WITNESS, S-2331")
- ◎ - 1-1/2" IRON PIPE FOUND

LINE	BEARING	DISTANCE
L1	N 57°32'52" E	41.67'
L2	S 50°05'39" E	42.63'
L3	S 30°41'24" W	44.43'
L4	N 87°28'46" W	30.87'

I found the PK nail as shown on the X-9 tie sheet prepared by Barnes, (1985). Only one tie from that tie-sheet remains and it was bent. I spun the monument and replaced in the same location, (as best can be determined), and the new monument checks to the PK within 0.06 feet of the previous dimension; I accepted the PK nail as the PLSS corner. Witnesses were established per the sketch.
