# U.S. PUBLIC LAND SURVEY MONUMENT RECORD

**T. 3 N. - R. 13 E. of the 4th P.M.**

HARMONY TWP  
ROCK COUNTY WI

Corner code: G 7

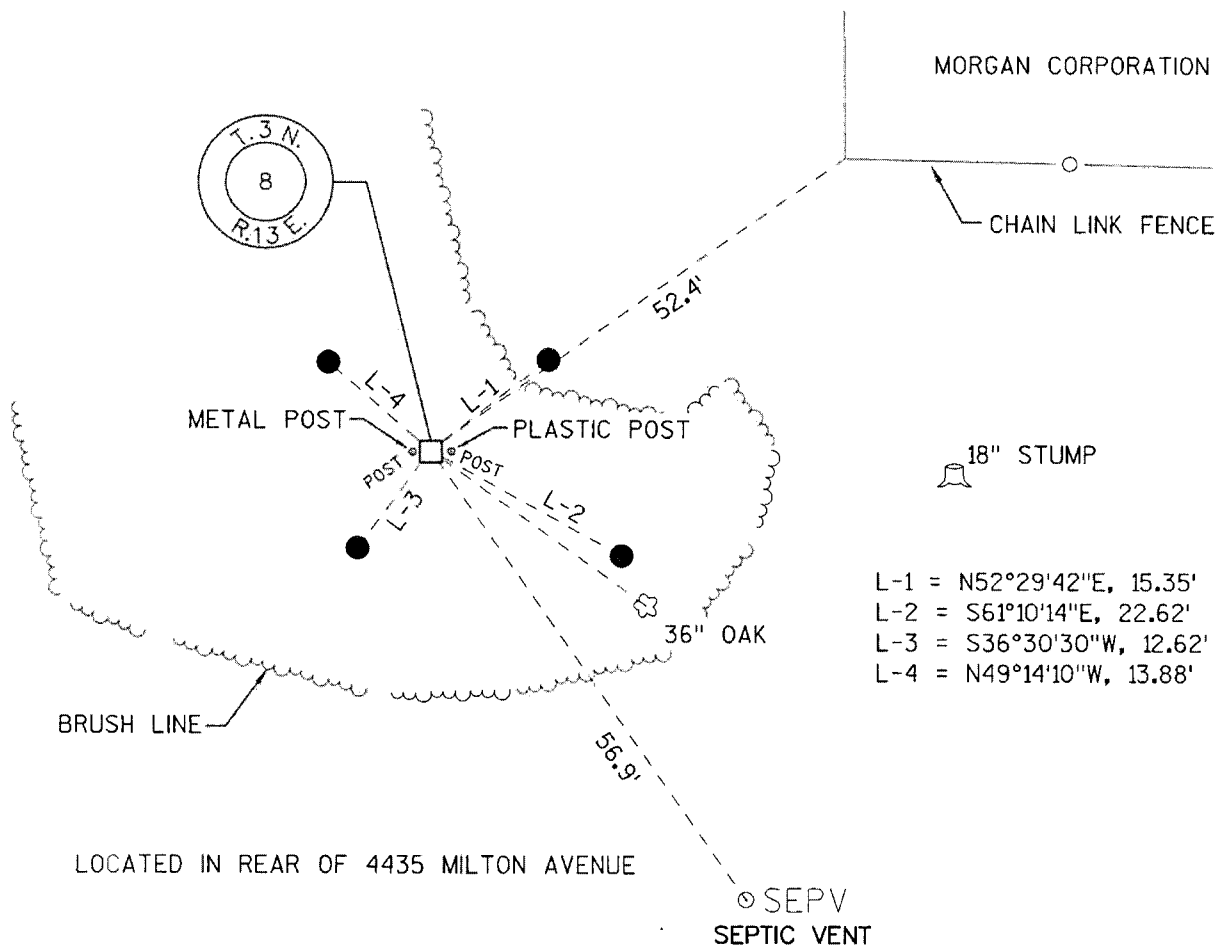
- - 3/4" x 24" REBAR SET
- - LIMESTONE FOUND

LOCATED IN REAR OF 4435 MILTON AVENUE

Found a cut "X" on a limestone monument, along with metal and plastic guard posts. Since the tie sheet used had no witness monuments or physical features shown, one was made for the monument.  
I accepted this monument as located.
