U.S. PUBLIC LAND SURVEY MONUMENT RECORD

T. 3 N. - R. 10 E. of the 4th P.M.

MAGNOLIA TWP
ROCK COUNTY WI

CORNER CODE: E-1
(A.E. 7.08 REQUIREMENT)

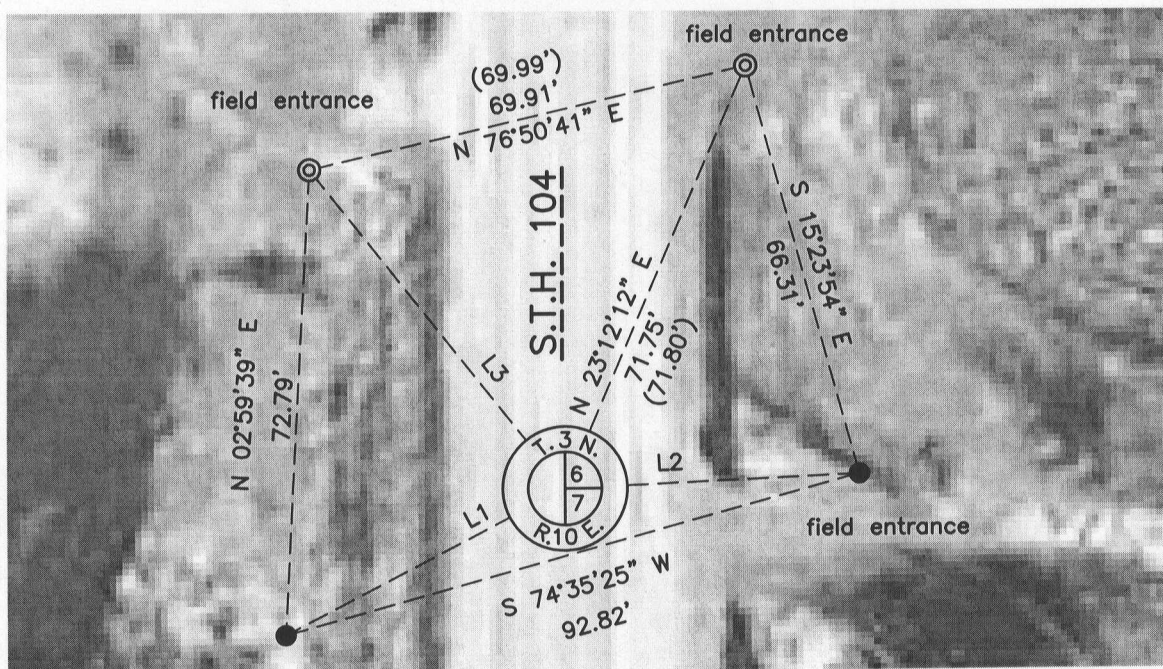
(a) LEGEND

- - 3/4" x 24" REBAR SET W/RED CAP
- ⊙ - IRON PIPE FOUND
- (#) - PREVIOUS TIE-SHEET DIMENSION

- ALUMINUM MONUMENT FOUND
(4", +/-, BELOW ASPHALT SURFACE)

LINE	BEARING	DISTANCE	
L1	N 62°33'08" E	49.14'	
L2	N 87°29'05" E	45.92'	
L3	N 38°30'01" W	63.94'	(63.82')

I found the aluminum monument at the PLSS corner and 3 intact witnesses from the most recent dimensioned tie-sheet, (Sausser-2009). Sausser did not excavate the aluminum monument and established it from ties. Subsequent to that, Barnes filed 3 tie-sheets at this location; one indicates a found aluminum monument that doesn't reference the Sausser ties and the other two are narratives concerning the offset between Rock and Green County corners at this, and other areas along the west side of Rock County.

At the time Sausser did his work, 2 intact ties remained on the east side of S.T.H. 104. After computing the PLSS location he set two additional ties west of the highway. At the time of my work one of the former ties, (SE), used by Sausser was bent. I hammer drilled out 4", +/-, of cold patch/blacktop and recovered the aluminum monument. I accepted the aluminum, surveyed both the original & Sausser witnesses, and set two additional witnesses per the map. I filled in the area over the aluminum w/recycled cold patch/asphalt.

I did not find a discrepancy between the corner restored and a previously documented corner location. *Discrepancy* being defined as *disagreeing* with a corner location, *not* as noting dimensional differences between current/former tie sheets due to measuring methods. The current and *most recent* tie-sheet dimensions filed for the corner are noted.
