U.S. PUBLIC LAND SURVEY MONUMENT RECORD

For Public Land Survey Corners In: WI ADMINISTRATIVE CODE A-E 7.08 REQUIREMENT
T. 3 N. - R. 10 E. of the 4th P.M.

MAGNOLIA TWP
ROCK COUNTY WI

Corner code: V-5(1)

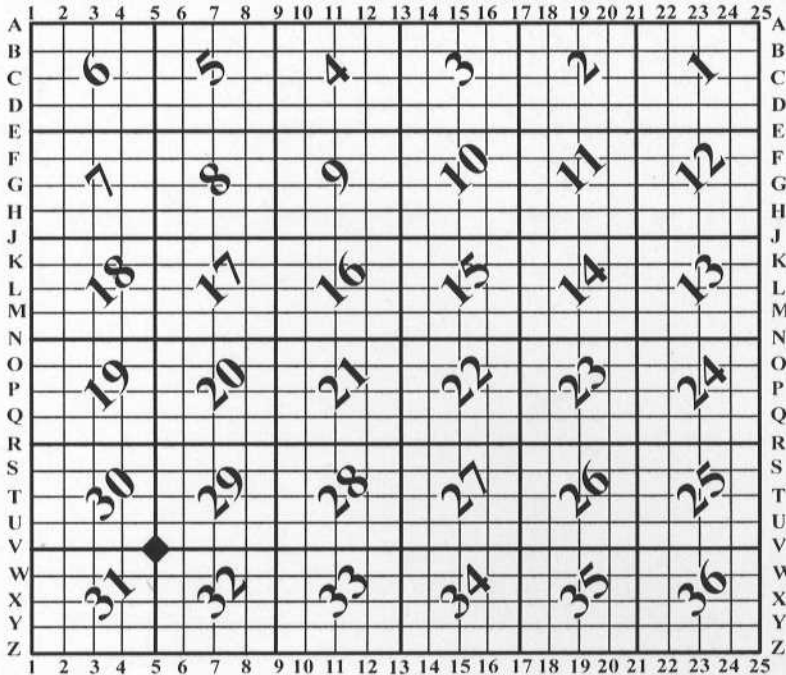
CORNER CODE INDEX

(PLACE "◆" SYMBOL AT PROPER PLSS CORNER LOCATION)

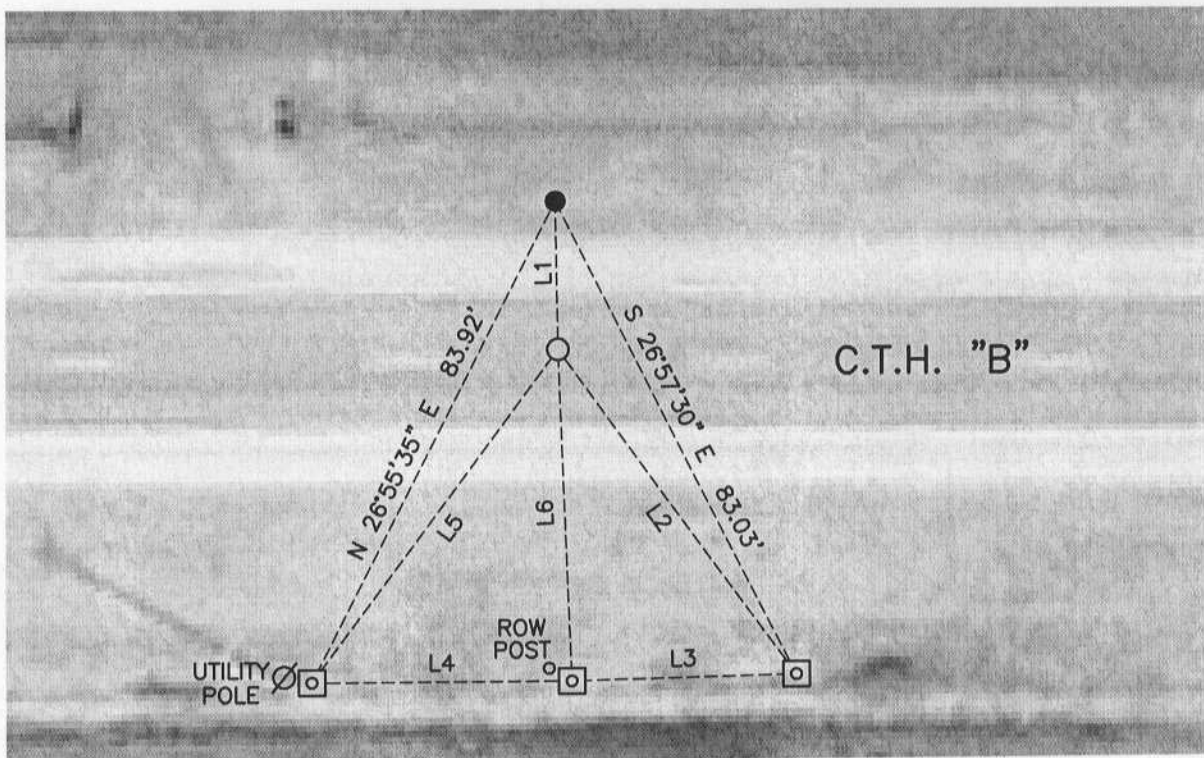
(a) LEGEND

- - 5/8" x 24" REBAR SET, (RED CAP W/"PLSS WITNESS")
- - "DURANAIL" ASPHALT NAIL SET
- ◻ - CONCRETE MONUMENT WITH BRASS DISK FOUND
(MONUMENTS ARE ROUGHLY 1 FOOT NORTH OF FENCE)
- (#) - PREVIOUS TIE-SHEET DIMENSION

LINE	BEARING	DISTANCE	
L1	S 01°02'21" E	23.12'	
L2	S 36°10'49" E	63.05'	(63.05')
L3	S 88°40'12" W	35.11'	(35.11')
L4	S 89°59'31" W	40.54'	(40.46')
L5	N 36°36'49" E	64.42'	(64.37')
L6	S 02°20'50" E	51.75'	(51.75')

I found three concrete WDOT monuments with brass caps as shown on tie-sheet V-5 filed in 1985; no monument or magnetic pull was found at the PLSS corner. Based on the two easterly WDOT monuments, the PLSS corner was calculated by a distance/distance intersection; a duranail asphalt nail was set at the corner. One additional witness was set per the sketch and ties to the third WDOT monument is within reasonable tolerances.

I did not find a discrepancy between the corner restored and a previously documented corner location. *Discrepancy* being defined as *disagreeing* with a corner location, *not* as noting dimensional differences between current/former tie sheets due to measuring methods. The current and *most recent* tie-sheet dimensions filed for the corner are noted.
