# U.S. PUBLIC LAND SURVEY MONUMENT RECORD

T. 3 N. - R. 10 E. of the 4th P.M.

MAGNOLIA TWP  
ROCK COUNTY WI

Corner code: N-17

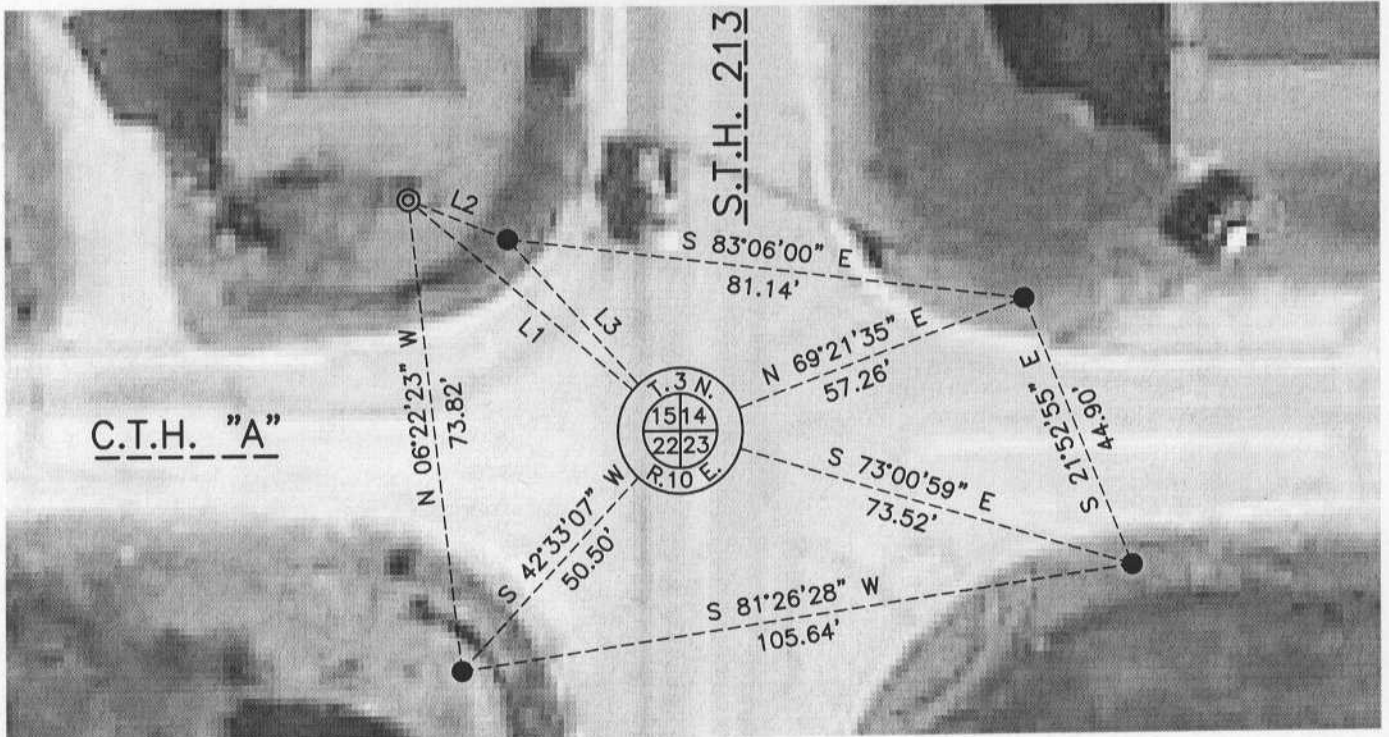
- - 3/4" x 24" REBAR SET W/RED CAP
- ⊙ - IRON PIPE FOUND
- (#) - PREVIOUS TIE-SHEET DIMENSION
- COTTON GIN SPINDLE SET IN PLACE OF A MASONRY NAIL FOUND WITH THE HEAD MISSING

LINE	BEARING	DISTANCE	
L1	N 49°30'00" W	55.68'	(55.65') & (55.68')
L2	S 67°56'26" E	16.59'	
L3	S 42°00'47" E	40.29'

I found a masonry nail with the head broken off and one witness per the N-17 tie-sheet, (Barnes-2000). It appears that much construction/ditch maintenance, house removal, etc. has occurred since that time. The two southeasterly witnesses are disturbed but generally match the masonry nail found; the northwest pipe found matches a previous tie-distance that Barnes disagreed with by 0.03'. This masonry nail has been used to establish the North ¼ corner of Section 23, (Combs-2010), on tie-sheet N-19. I accept the masonry nail found given its apparent age, dimension to the northwest tie and proximity to those that are disturbed; additionally, it has been used to perpetuate other PLSS corners. In place of the broken nail, I set a cotton gin spindle and set four additional witnesses per the map.

I did not find a discrepancy between the corner restored and a previously documented corner location. *Discrepancy* being defined as *disagreeing* with a corner location, *not* as noting dimensional differences between current/former tie sheets due to measuring methods. The current and *most recent* tie-sheet dimensions filed for the corner are noted.
