U.S. PUBLIC LAND SURVEY MONUMENT RECORD

T. 3 N. - R. 10 E. of the 4th P.M.

MAGNOLIA TWP
ROCK COUNTY WI

Corner code: R-1

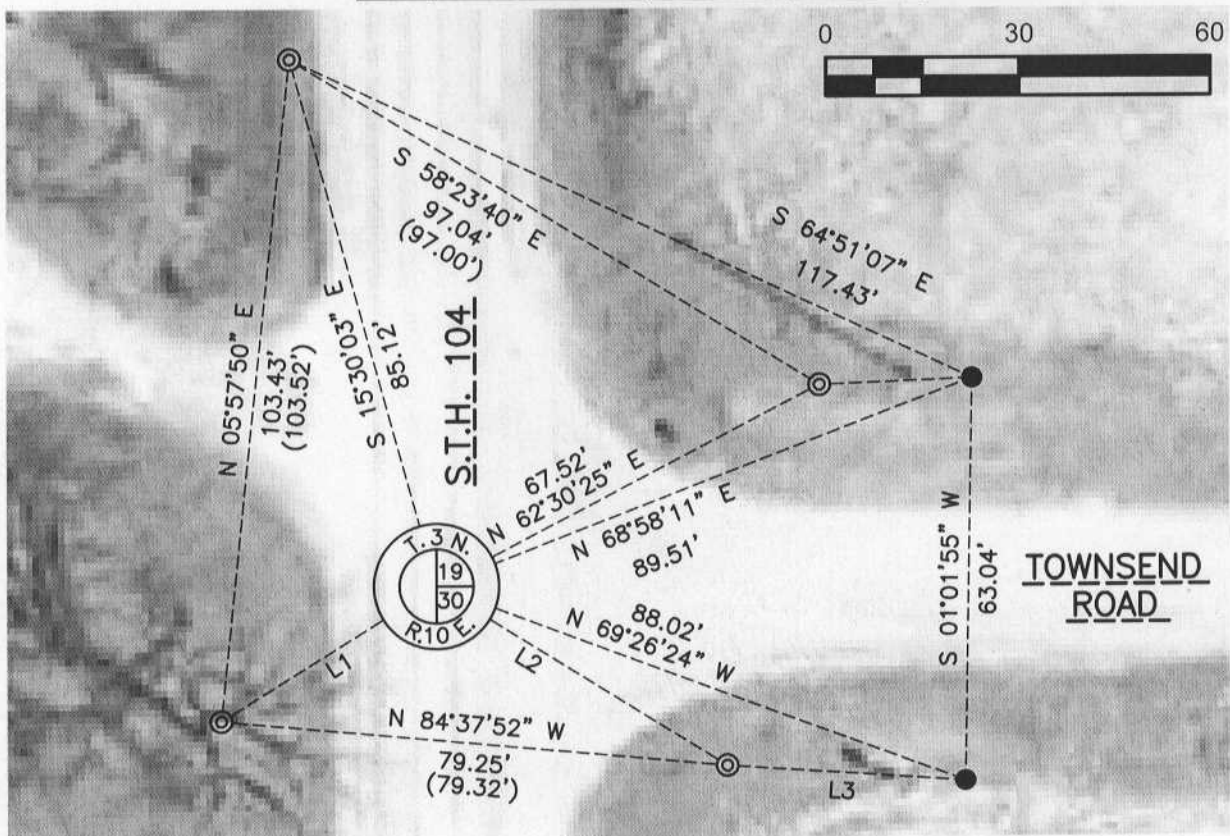
(a) LEGEND

I found four witnesses per the R-1(1) tie-sheet, (Barnes-2007), and there is not a surface monument. Barnes found the monument disturbed in 1996 and since then, it has been paved over. I did not excavate for a monument at the PLSS corner. From the two northerly monuments I computed the corner by distance/distance intersection; I set a cotton gin spindle at the PLSS corner and two additional witnesses per the map.

I did not find a discrepancy between the corner restored and a previously documented corner location. *Discrepancy* being defined as *disagreeing* with a corner location, *not* as noting dimensional differences between current/former tie sheets due to measuring methods. The current and *most recent* tie-sheet dimensions filed for the corner are noted.
