# U.S. PUBLIC LAND SURVEY MONUMENT RECORD

T. 3 N. - R. 10 E. of the 4th P.M.

MAGNOLIA TWP  
ROCK COUNTY WI

**CORNER CODE: X-21(3)**  
(A.E. 7.08 REQUIREMENT)

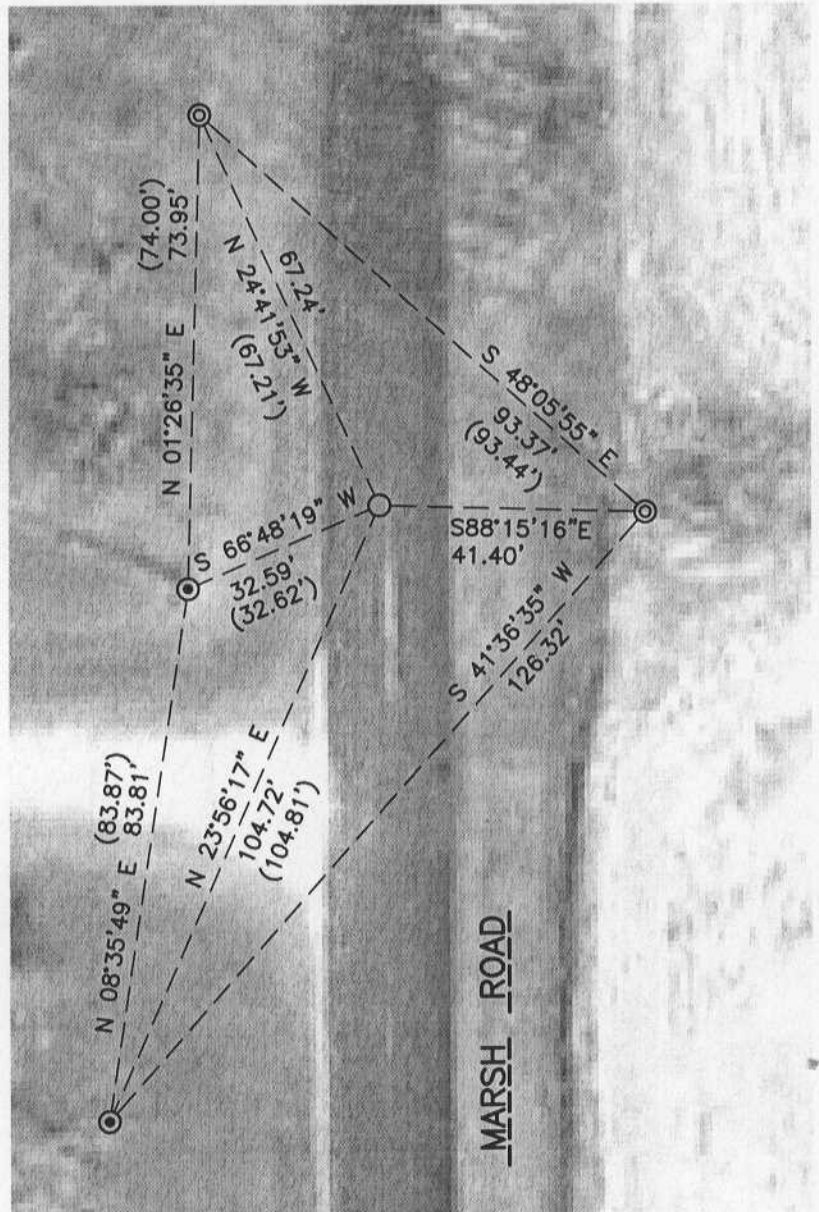
(a) LEGEND

I found the pk nail and ties per the X-21 tie sheet filed in 1988. The pk nail did not check the ties and the head was found to be nearly sheared off and leaning. I removed the top layer of asphalt/sealer and found the base of the pk nail and surveyed/accepted the same as the PLSS corner location; a cotton gin spindle was set in the location of the pk base. A magnetic pull exists below. I accepted the four witnesses as found and set a cotton gin spindle per the sketch; ties to the witnesses are well within expected tolerances.

I did not find a discrepancy between the corner restored and a previously documented corner location. *Discrepancy* being defined as *disagreeing* with a corner location, *not* as noting dimensional differences between current/former tie sheets due to measuring methods. The current and *most recent* tie-sheet dimensions filed for the corner are noted.
