U.S. PUBLIC LAND SURVEY MONUMENT RECORD

T. 3 N. - R. 10 E. of the 4th P.M.

MAGNOLIA TWP
ROCK COUNTY WI

CORNER CODE E-23(1)

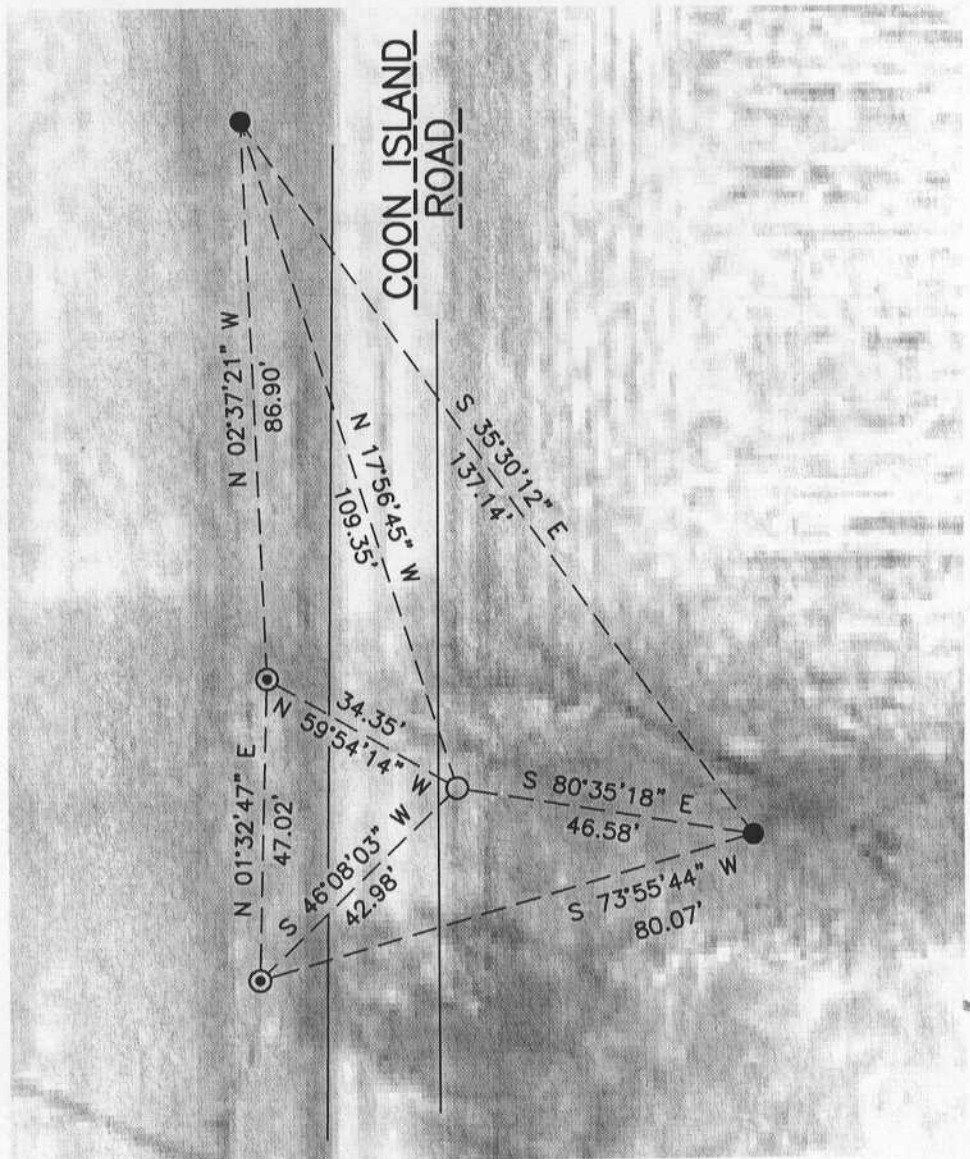
(a) LEGEND

- - 5/8" x 24" REBAR SET, (RED CAP W/"PLSS WITNESS")
- - ALUMINUM MONUMENT SET. REPLACES BROKEN MONUMENT FOUND/SURVEYED/REMOVED
- ⊙ - DISTURBED IRON REBAR FOUND & RESET

I found the aluminum monument near the edge of pavement and listened for the magnetic pull of the erroneous monument to the East. The correct monument has been disturbed and is also broken off. Upon excavating, the base of the monument was found to be intact. The "T" of the broken monument was surveyed and I set a new aluminum monument in its place. Much work has occurred in this area since the 1994 tie-sheet, (E-23), and all ties were either missing or disturbed. The new aluminum was set 2-3" below grade and witnessed per the sketch.

Accepted found location of the base of a broken aluminum monument.
