# U.S. PUBLIC LAND SURVEY MONUMENT RECORD

T. 3 N. - R. 10 E. of the 4th P.M.

MAGNOLIA TWP

ROCK COUNTY WI

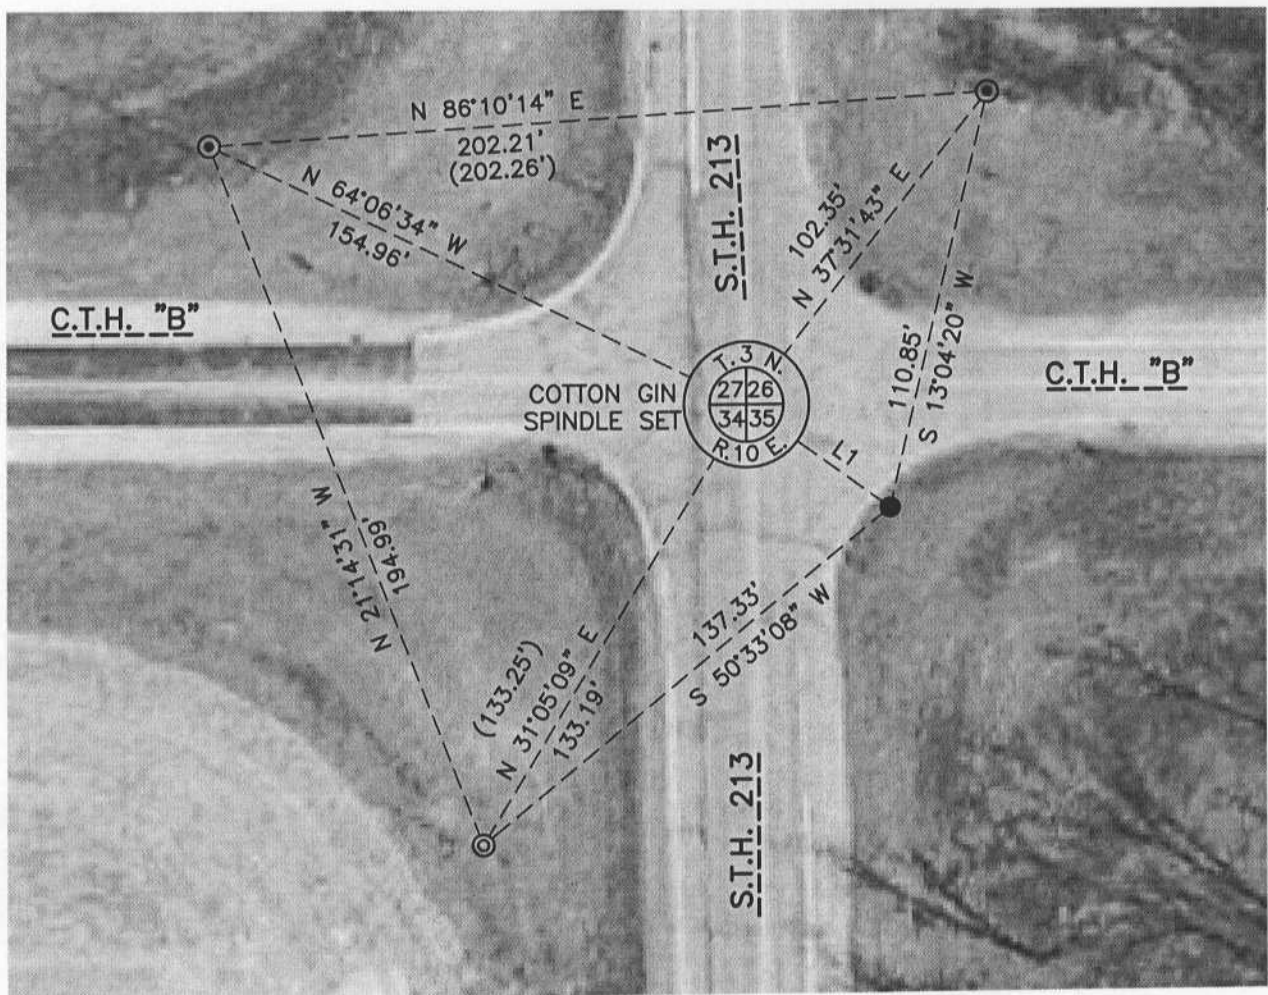
**(a) LEGEND**

LINE	BEARING	DISTANCE
L1	S 54°16'39" E	45.91'

I found a plowed/bent over railroad spike at the PLSS corner and three of the four witnesses on the V-17(2) tie-sheet prepared by Lathrop, (2013); the fourth witness was found to be disturbed. I calculated the corner location by distance/distance intersection from the two northerly ties; the dimension to the 3<sup>rd</sup> tie, (Southwest), checks to 0.06'. I set a cotton gin spindle at the PLSS corner location and a 4<sup>th</sup> witness per the sketch.

This PLSS corner was obliterated and restored from record witnesses.

I did not find a discrepancy between the corner restored and a previously documented corner location. *Discrepancy* being defined as *disagreeing* with a corner location, *not* as noting dimensional differences between current/former tie sheets due to measuring methods. The current and *most recent* tie-sheet dimensions filed for the corner are noted, (Lathrop, 2013).
