U.S. PUBLIC LAND SURVEY MONUMENT RECORD

T. 3 N. - R. 10 E. of the 4th P.M.

MAGNOLIA TWP
ROCK COUNTY WI

CORNER CODE: Z-19(3)
(A.E. 7.08 REQUIREMENT)

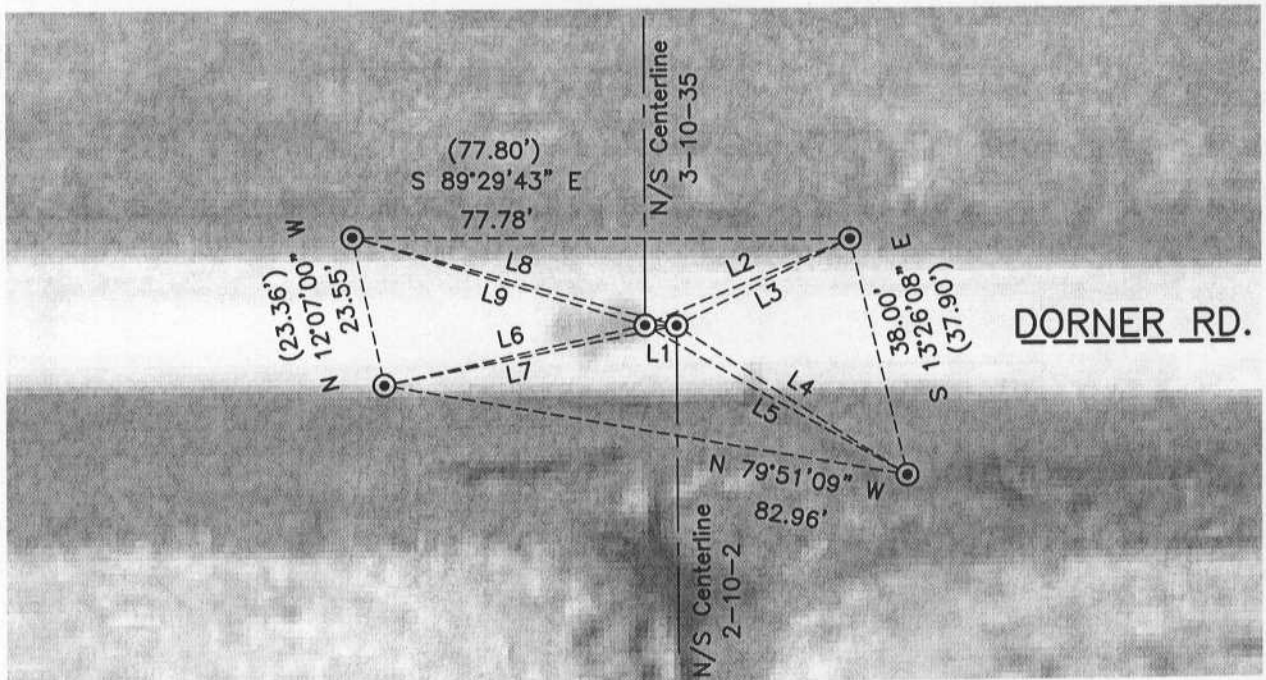
(a) LEGEND

- ⊙ - IRON REBAR FOUND
- (#) - PREVIOUS TIE-SHEET DIMENSION

LINE	BEARING	DISTANCE	
L1	N 89°03'52" W	4.93'	(4.93')
L2	N 67°28'27" E	34.68'	(34.68')
L3	S 63°45'12" W	30.22'	(30.18')
L4	S 56°42'46" E	42.99'	(43.02')
L5	N 59°54'46" W	47.22'	(47.25')
L6	S 77°28'59" W	41.79'	(41.72')
L7	N 78°53'32" E	46.60'	(46.56')
L8	N 74°30'07" W	52.58'	(52.54')
L9	S 73°01'05" E	47.83'	(47.77')

I found the iron rebar at the South ¼ of Section 35 as shown on the Z-19(2) tie-sheet filed in 1998. I also found the four witness rods/rebar and North ¼ corner of section 2-10-2 shown on the same; All ties check to reasonable tolerances and I accepted the position of all monuments, as shown.

*NOTE: The North ¼ of 2-10-2 was bent however, only the top 4" +/- . I spun/straightened and reset; the top has been shaven from plowing so it looks like a ¼" x ¾" rod.

I did not find a discrepancy between the corner restored and a previously documented corner location. Discrepancy being defined as *disagreeing* with a corner location, *not* as noting dimensional differences between current/former tie sheets due to measuring methods. The current and *most recent* tie-sheet dimensions filed for the corner are noted.
